Meridian Hill Park Cultural Landscape Report Vol. 1

National Park Service - National Capital Region
Contract #: 1443X300094034
architrave, p.c. architects, Washington, D.C

31 August 2001

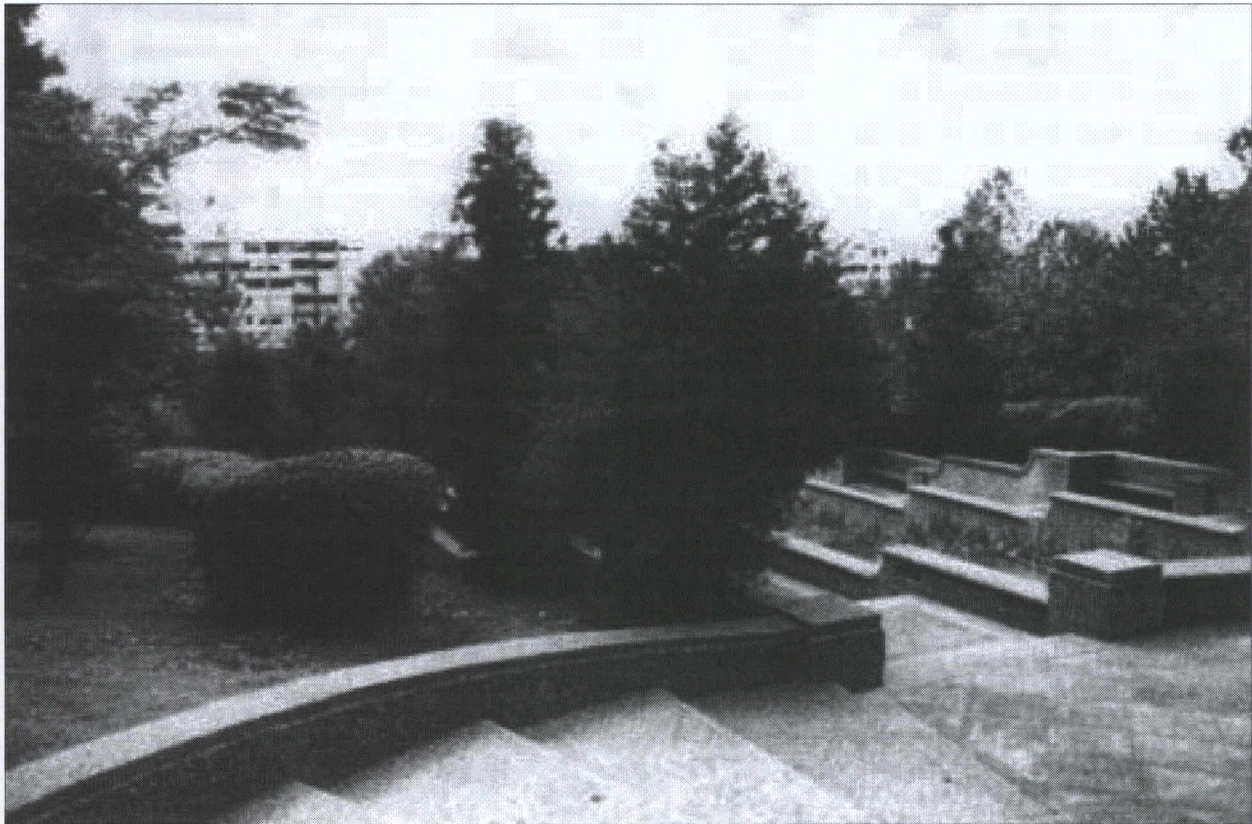
Figure 123: 1996 view of cedar trees before replacement and holly shrubs bordering cascades, looking southwest across lower gardens. Note the gap in the holly hedges visible to the left and the hedge itself without the flat top and sides it should have. (Land Ethics, Inc., 1996).

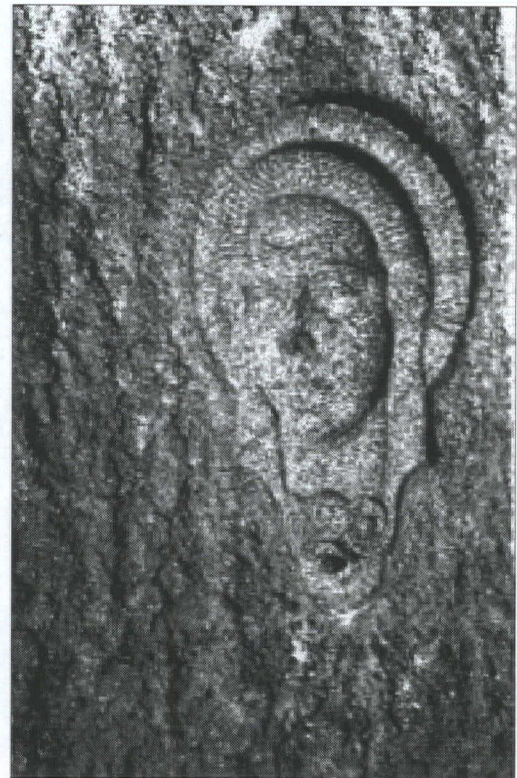
Figure 149: Sculptural wall-mounted fountain mast at fountain located at the base of the stairs in the main 16th Street entrance, 1997. The entire lip of the receiving basin for this feature is missing. (Land Ethics, Inc.)

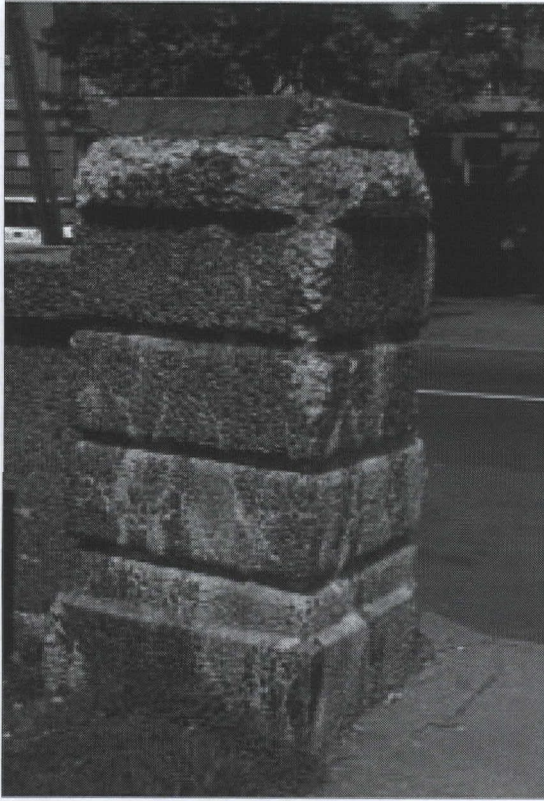
Figure 173: One of several piers in the park's enclosing wall that have a great deal of efflorescence and are seriously deteriorated. This one is at the entrance to the park by the upper play area. 1997, see plan sheet 28 (Land Ethics, Inc.).

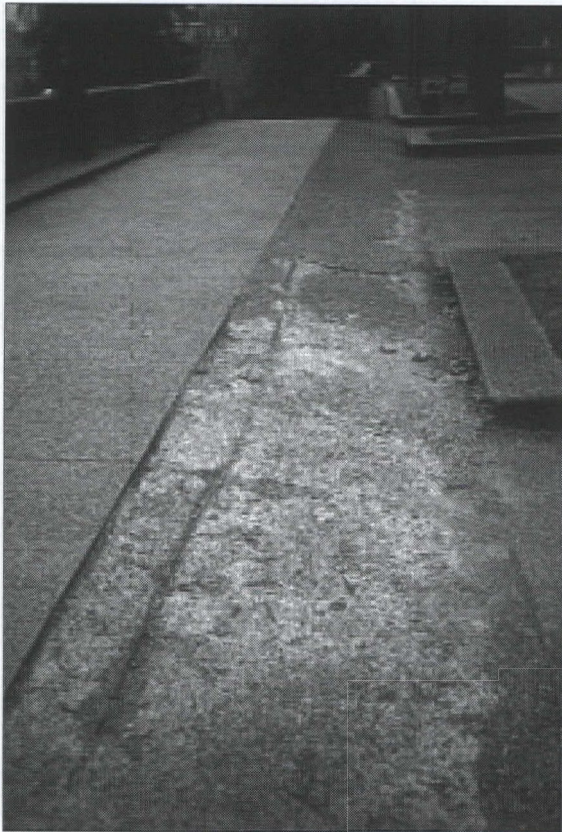
Figure 199: Portions of exposed aggregate pavement on the great terrace are in very poor condition, 1997, plan sheet 32 (Land Ethics, Inc.).

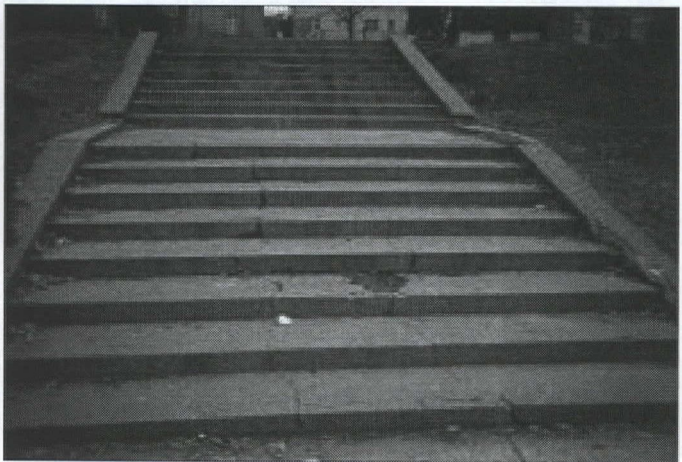
Figure 201: Entering the northwest corner of the park from 16th Street. Note that some of the concrete risers are cracked and damaged, 1997, see plan sheet 34 (Land Ethics, Inc.).

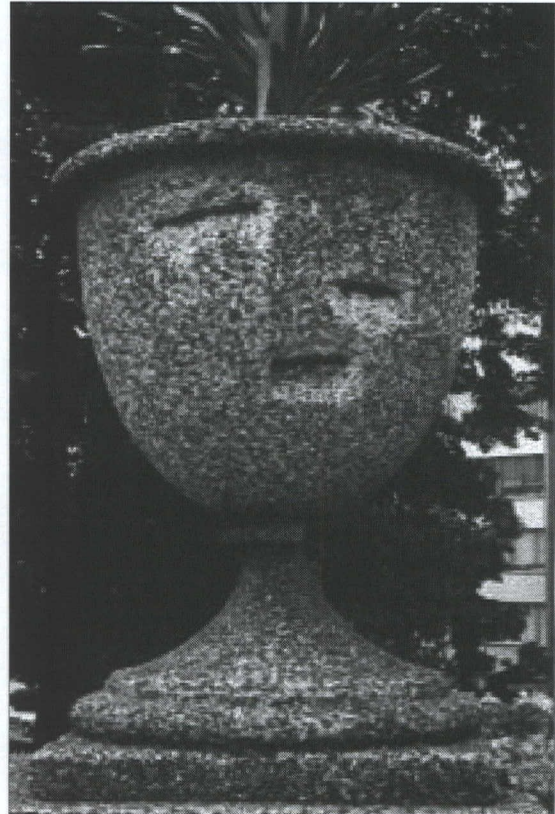
Figure 235: The exposed aggregate surfaces on each of the six planting urns in the exedra are damaged with portions of rusted reinforcing visible, 1997, (Land Ethics, Inc.).

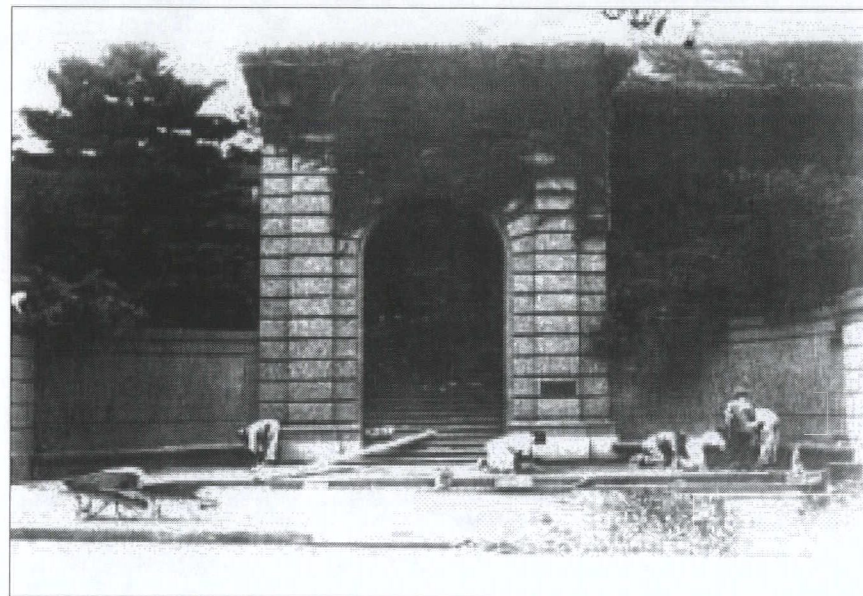
Repairs at 16th Street entrance (RCP-CRF, July 2, 1929).

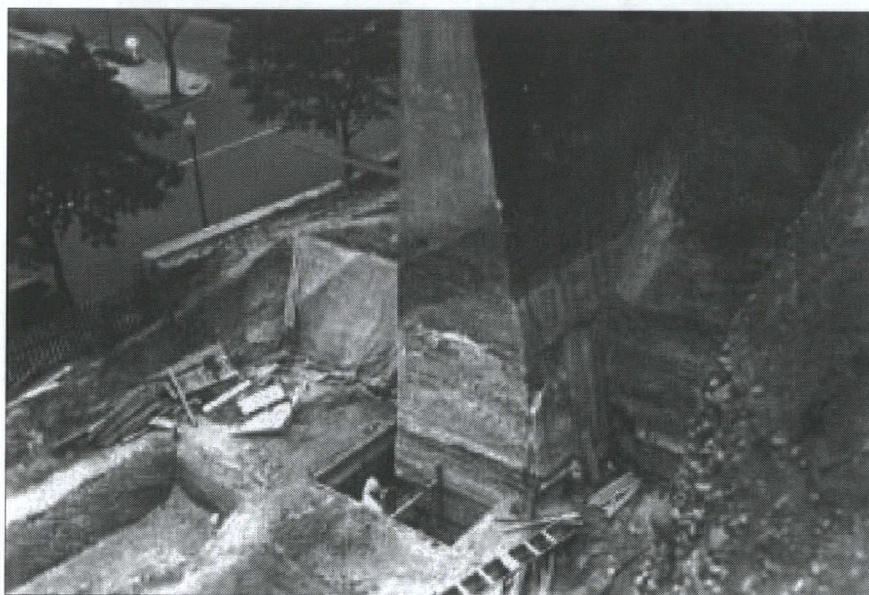
Wall underpinning at 16th Street (RCP-CRF, October 25, 1929).

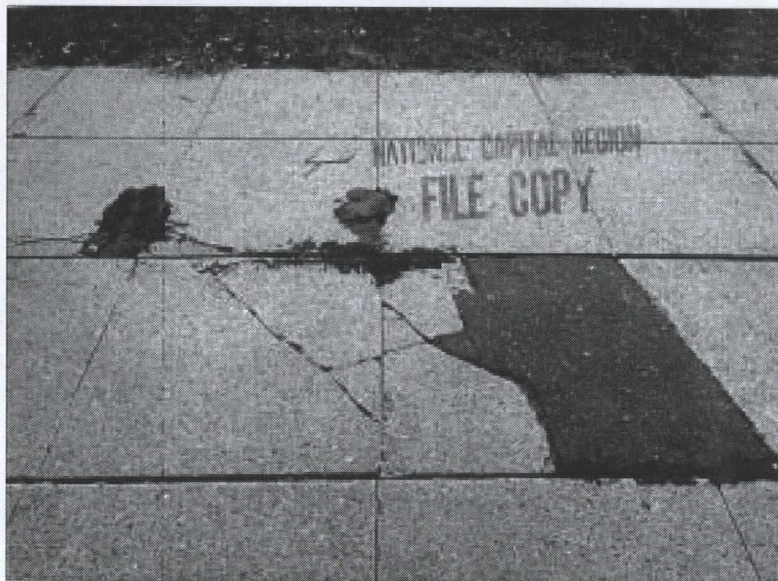
Concrete cracking and temporary patch (MRCE, November 1964). Pavement repaired in 1982.

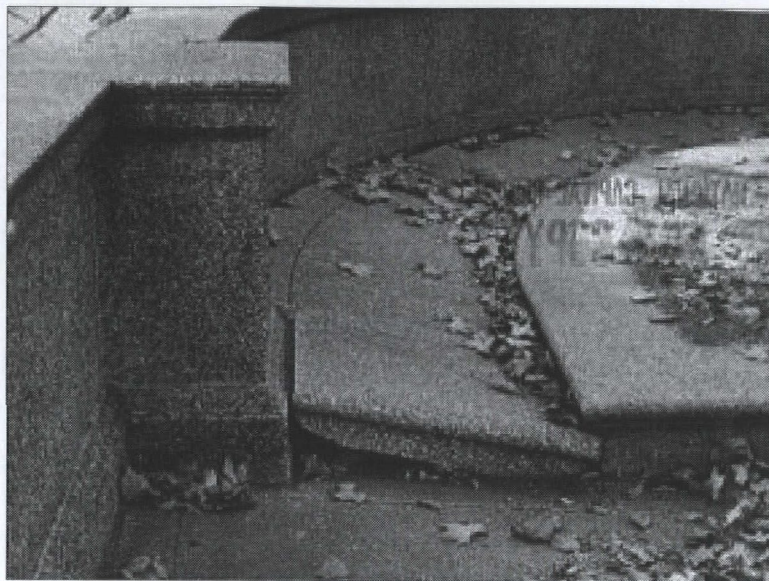
Settlement at great terrace (MRCE, November 1964). Repaired in 1982.

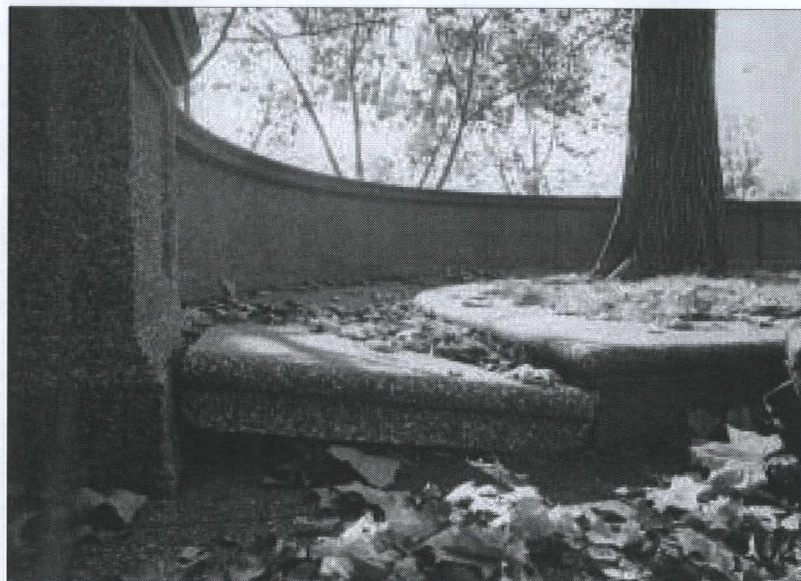
Settling and concrete damage along great terrace (MRCE, November 1964). Repaired in 1982.
